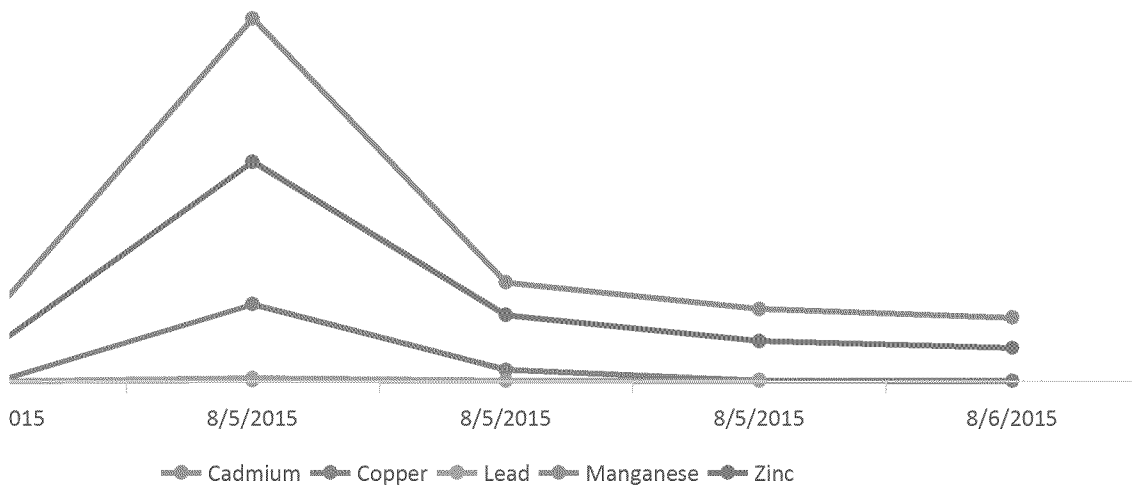
Location: A72

Location ID	De Sampled	Cadmium	Copper	Lead	Manganese	Zinc
A72	8/5/2015	1.81	9.27	0.225	1370	699
A72	8/5/2015	15.2	1410	50.7	6650	4020
A72	8/5/2015	4.29	205	3.12	1810	1210
A72	8/5/2015	2.59	11.4	0.118	1320	733
A72	8/6/2015	2.11	7.63		1160	609
